## **SUPERFICIAL TREATMENT RECOVER FOR THE VALENCIAN HISTORICAL MANUFACTURATES.**

**Authors:** Ana Torres Barchino, Begoña Saiz Mauleón, Ángela García Codoñer, Santiago Tormo Esteve.

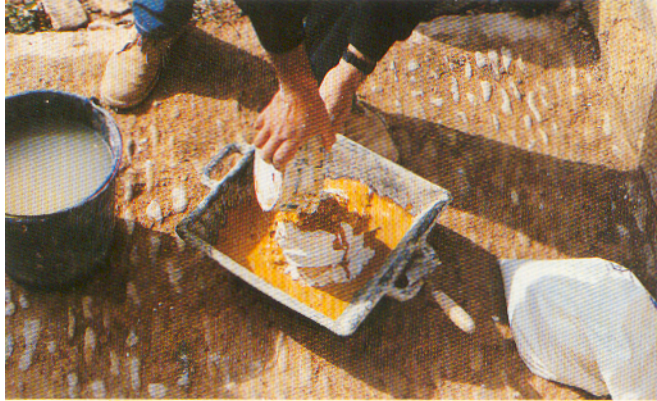
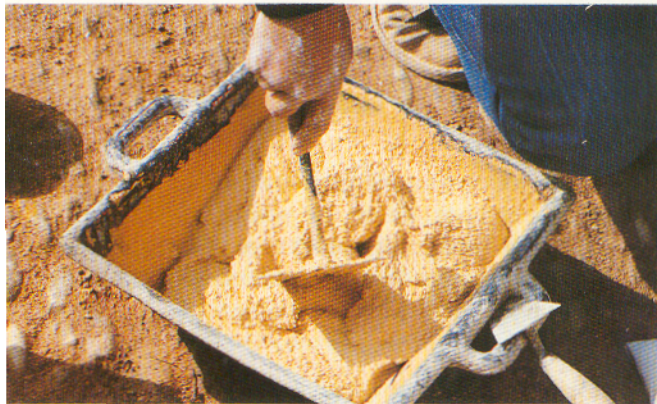
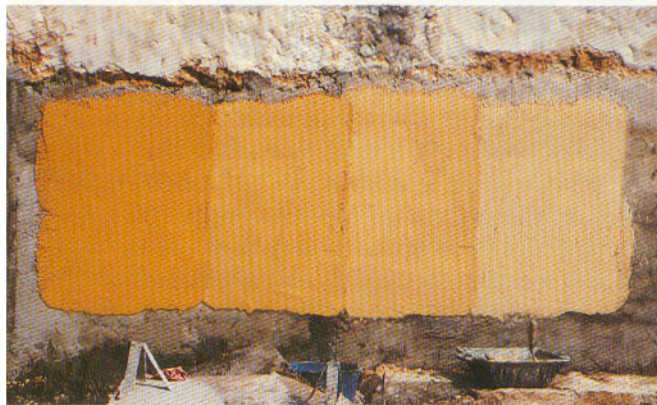
*Proceso de ejecución del revoco coloreado*
